Structural Condition Assessment
River Terminal Dock Structure
Hartsville, Tennessee

PowerCom Industrial Center

Four Lake Regional Industrial
Development Authority

May 17, 2016

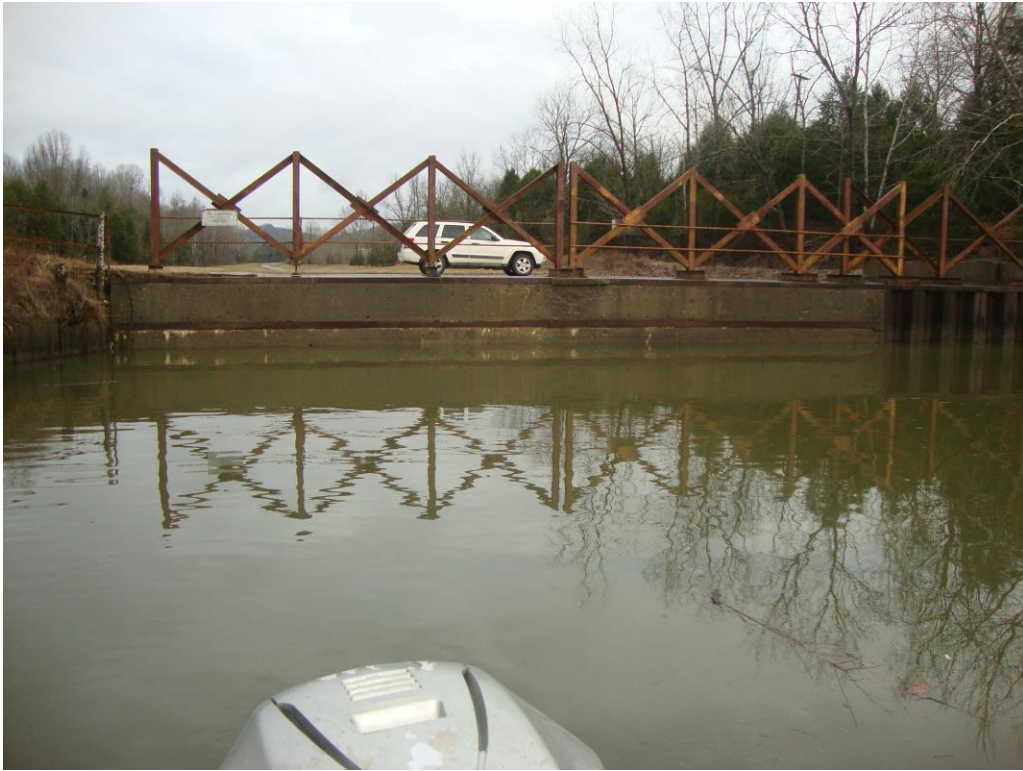
The face and top edge of the concrete mat along the west half of the south side had some spalls with exposed reinforcement bars, delaminations, and scaling of the concrete.

Photo 1 – South Elevation of Dock (West Half)

- Structural Repair of Concrete
 - Remove all unsound concrete, corrosion, and marine growth.
 - Supplement deteriorated or damaged reinforcement bars, if required.
 - Clean existing reinforcement bars.
 - Form and place concrete.
- Fill Scour Hole Under Southeast Corner of Concrete Mat
 - Core drill through concrete mat.
 - Form perimeter edges of concrete mat.
 - Place controlled low-strength material (flowable fill)
- Patch Existing Sheet Pile Hole
 - Grind existing edges of the hole flush.
 - Install and weld reinforcement plate to the existing sheet piles.

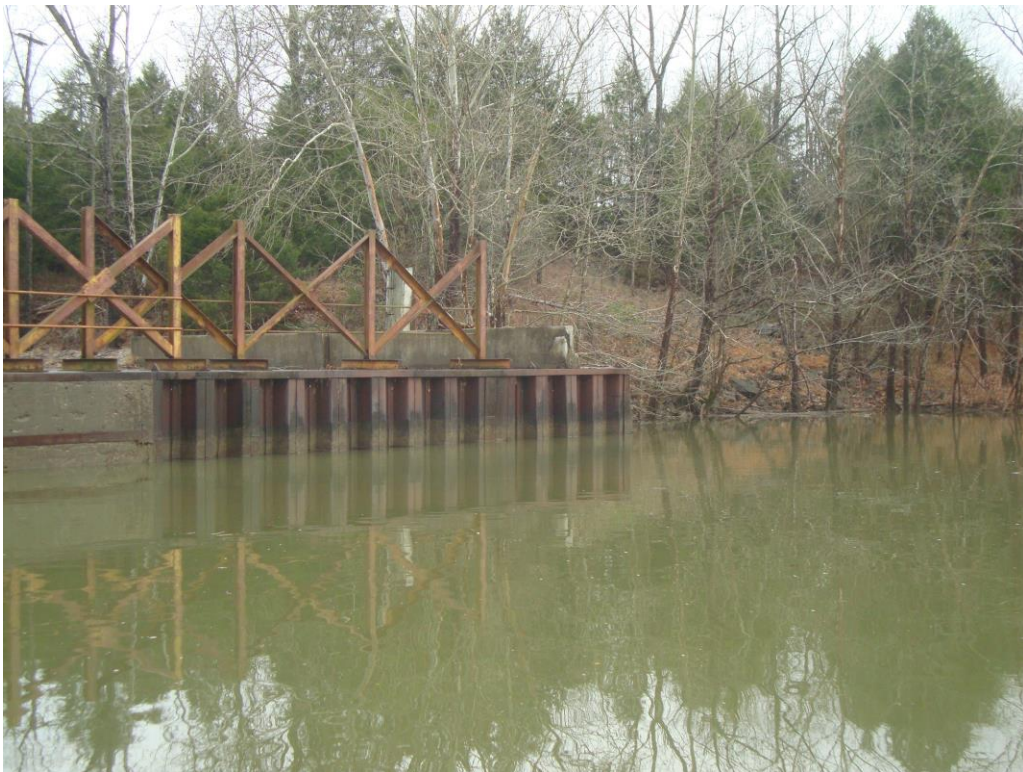
Photo 2 – South Elevation of Dock (East Half)

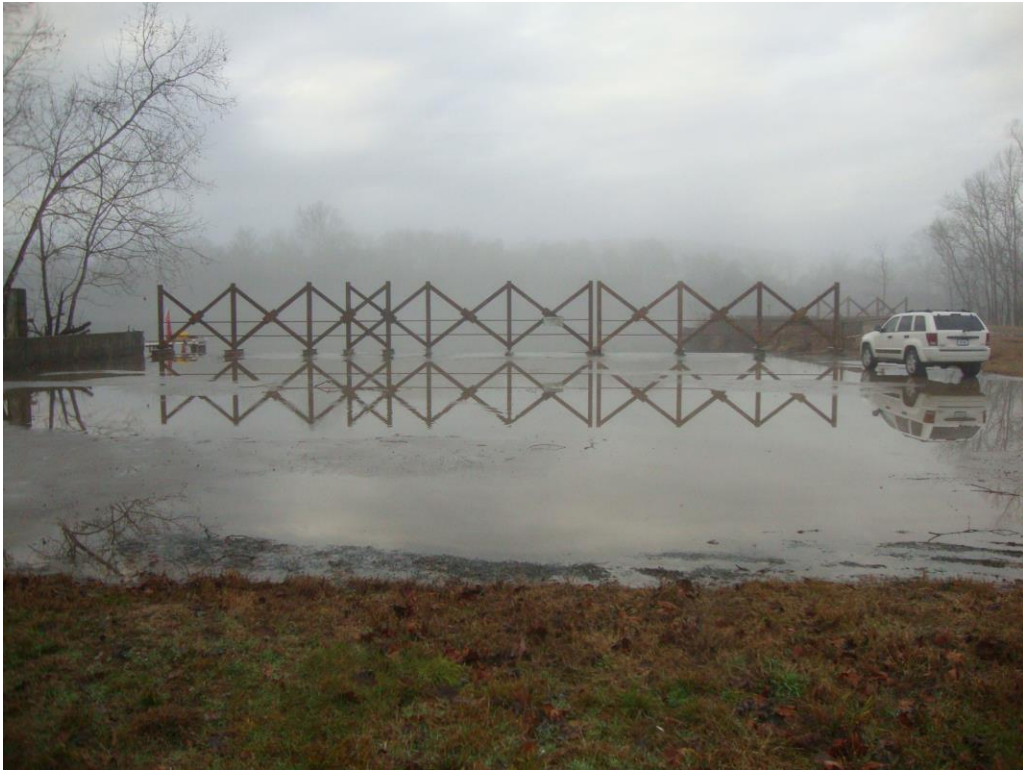
The concrete mat itself appeared to be in relatively good condition. However, there does not appear to be any construction joints in the concrete mat. There were some cracks visible on the top surface of the concrete, but they all appeared to be relatively tight with minimal horizontal or vertical separation. In general, these cracks were spaced relatively far apart.

The top surface of the concrete mat was slightly uneven. No survey shots were taken; however, on the day of the site visit, water was ponding on top of the concrete mat. Part of the mat was covered with water with a maximum depth of approximately 1 inch, while other parts were free of standing water.

Photo 3 – Looking South Across Dock

The proposed usage of the dock is unclear at this time. Therefore, the ponding of water on the top of the concrete mat has not been addressed. If the uneven surface is unacceptable to the Owner/User, then a concrete leveling slab may need to be placed over the top of the existing concrete mat. At that time, the Owner/User can determine the concrete thickness, jointing configuration, and reinforcement requirements.

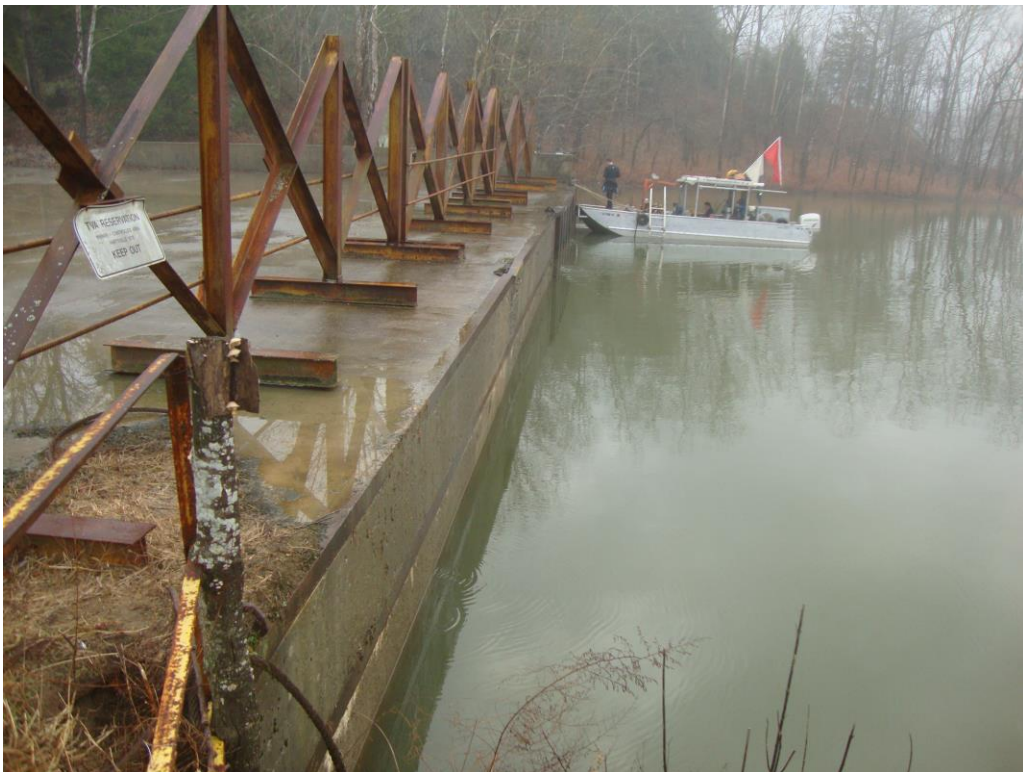
Photo 4 – Looking East Along South Edge of Dock

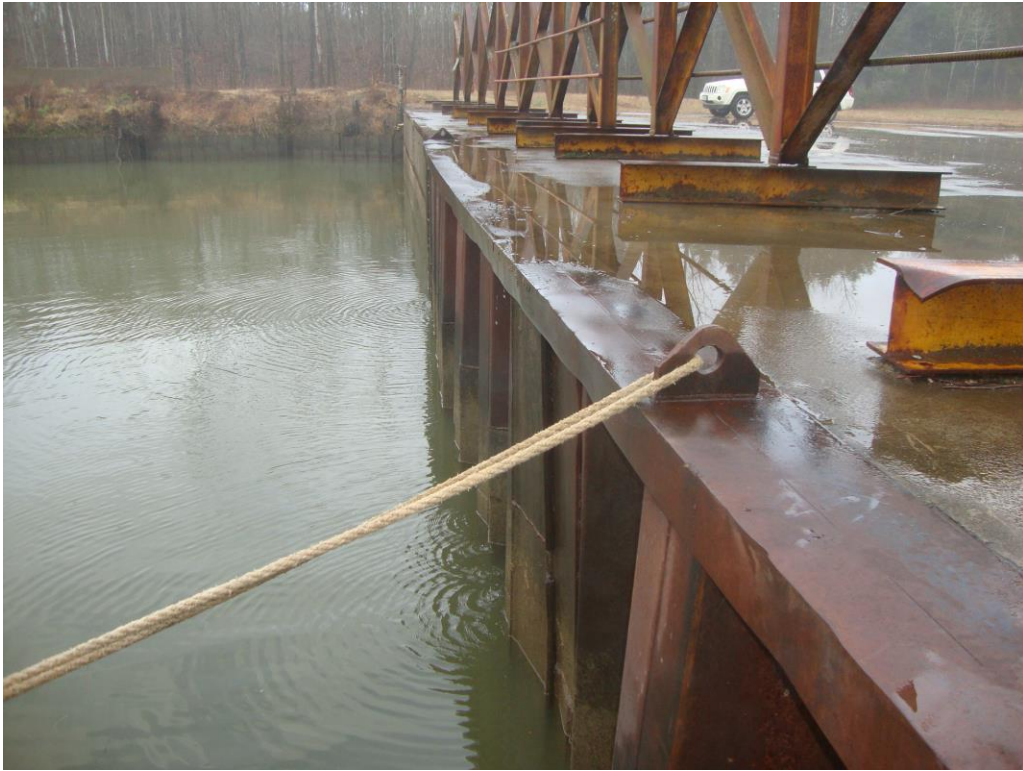
Photo 5 – Looking West Along South Edge of Dock

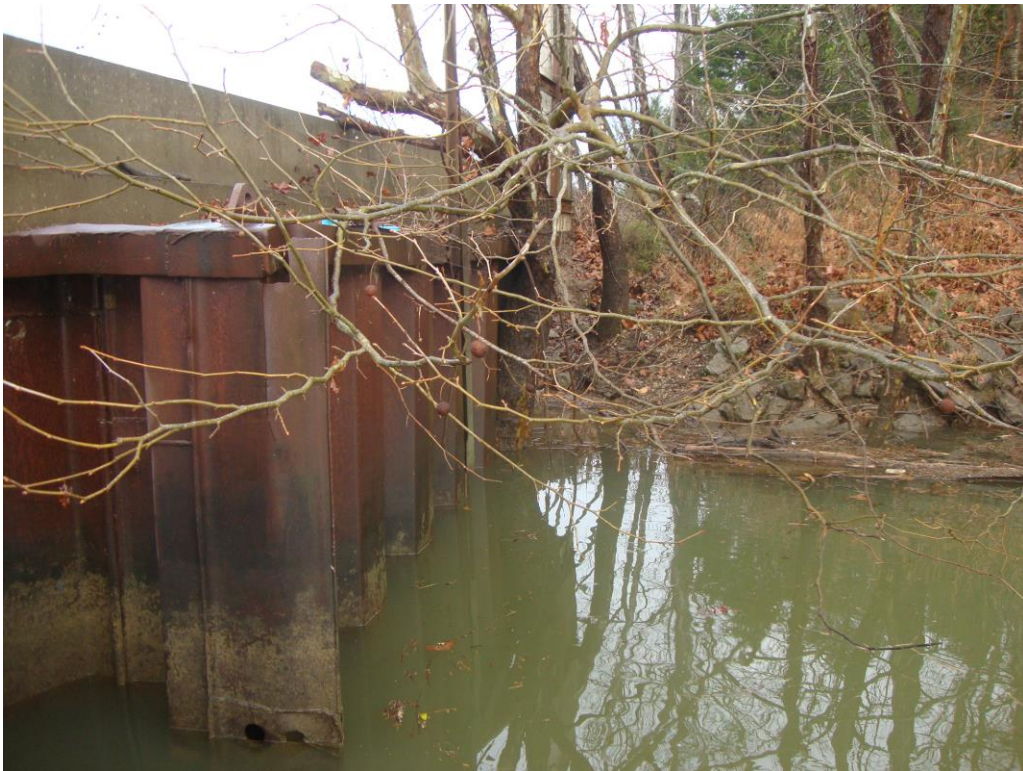
The soil underneath the concrete mat at the southeast corner of the dock was scoured, as previously stated. The scoured area was approximately 8.5 feet wide (east - west direction) and 27 feet long (north - south direction) by a maximum depth of 2 feet.

Photo 6 – Looking North at Southeast Corner of Dock

Hanson recommends the following repairs be performed to the River Terminal Dock Structure. In addition, Hanson recommends an area 10 feet wide (east - west direction) and 30 feet long (north - south direction) at the southeast corner of the dock structure be limited to light material storage or equipment no heavier than a conventional pickup truck. This corresponds with a previously described scour area.

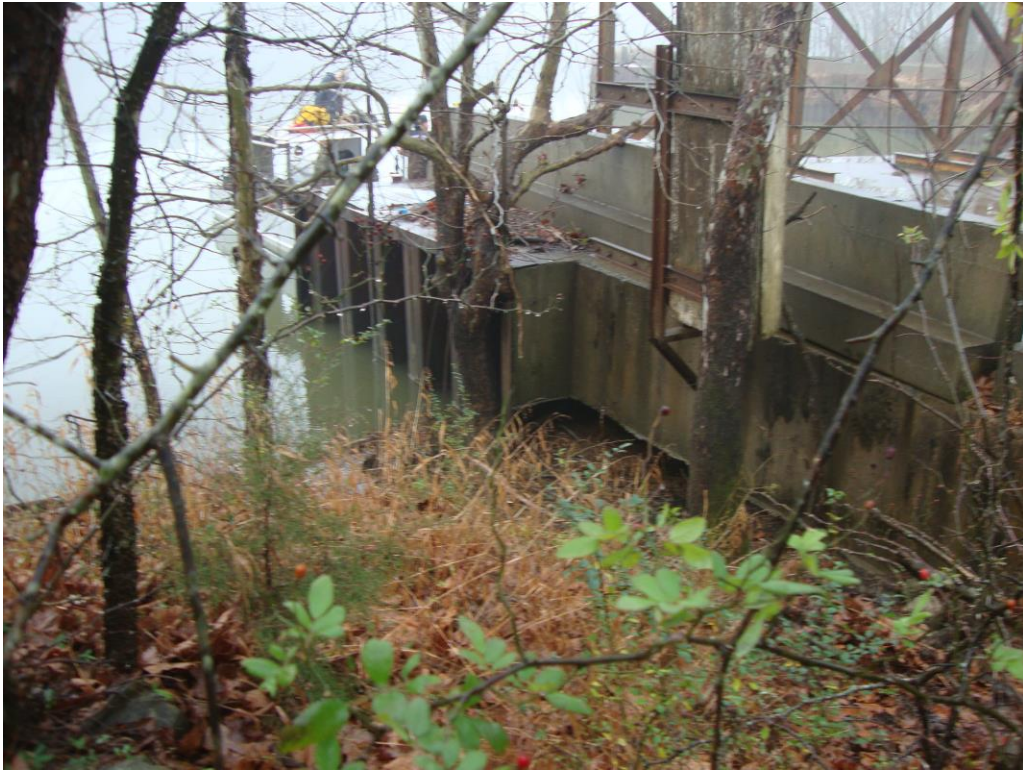
Photo 7 – Looking Southwest at Southeast Corner of Dock

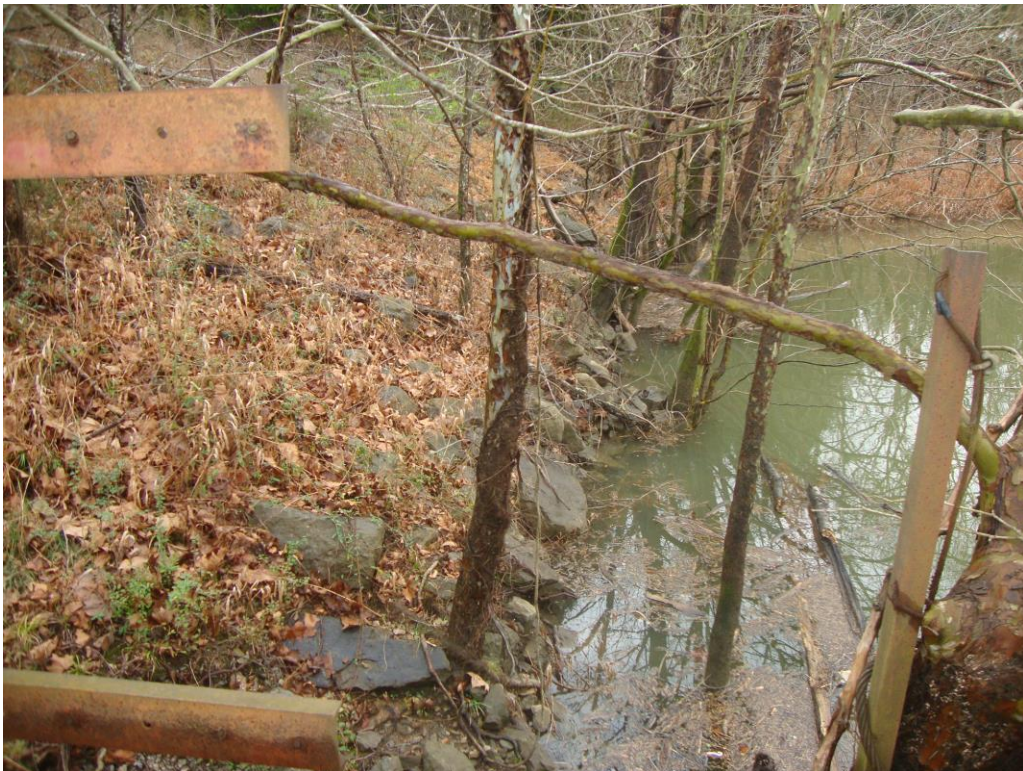
The remainder of the slack water area north shoreline is protected by small stone riprap. Many trees of varying sizes are growing through the stone riprap bank protection. See Photos 8 and 9 for the general condition of the shoreline in this area.

The slack water area shoreline had eroded immediately east of the dock. This area was approximately 20 feet long by 20 feet wide. The slack water area shoreline had also eroded immediately south and west of Cell 7. This area was approximately 50 feet long by 30 feet wide. The shoreline had eroded and left an exposed soil vertical face.

Photo 8 – Looking East along the North Shoreline, East of Dock

- Tree Removal
 - Remove all trees and samplings in the areas that have been eroded.
- Riprap
 - Prepare base for the placement of riprap bedding.
 - Place properly sized riprap bedding.
 - Place properly sized riprap.

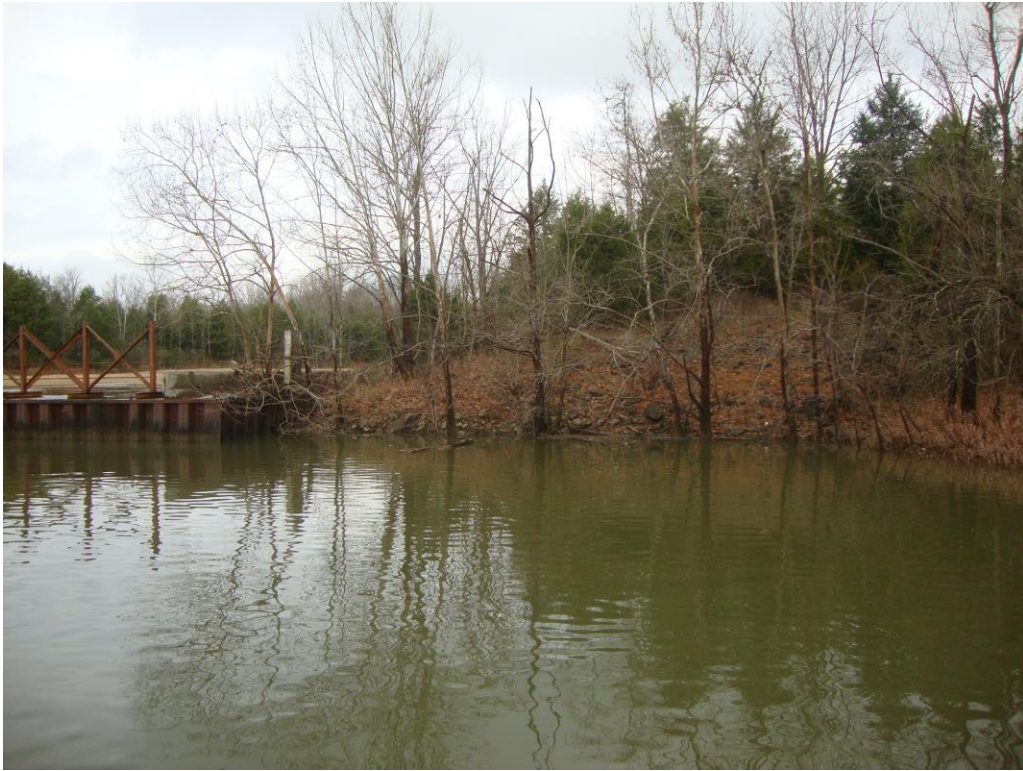
Photo 9 – Looking North along the North Shoreline, East of Dock

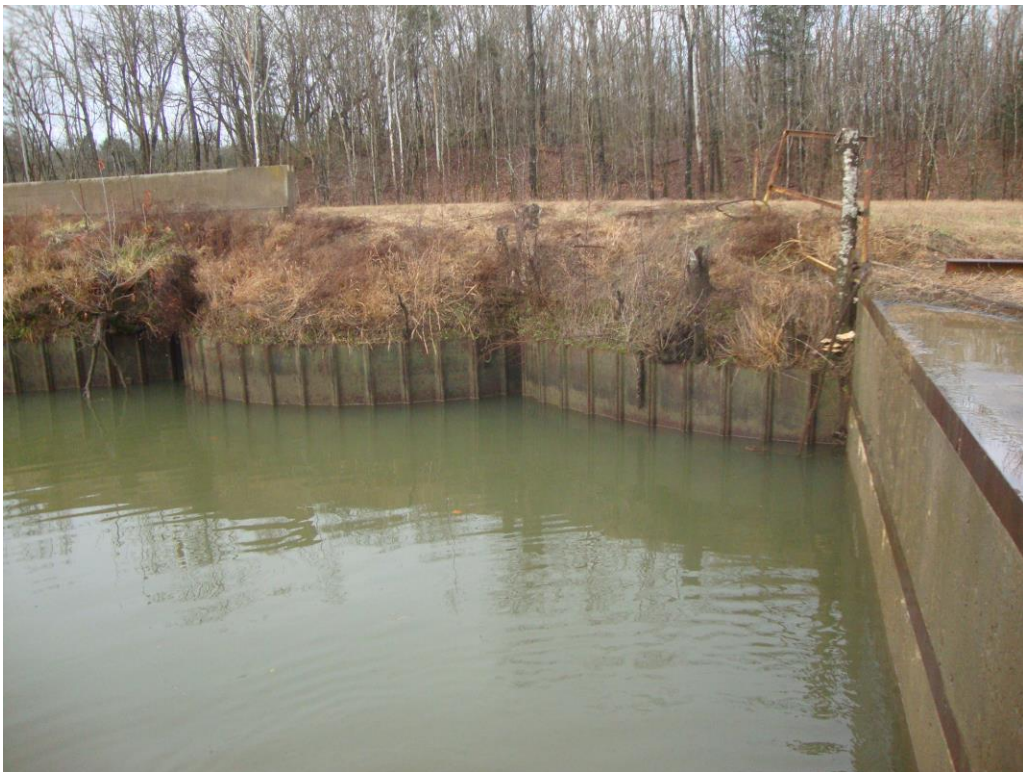
The steel “plate” type sheet piles were in fair condition. No splits or separations were observed in the steel sheet piles during the site visit. The Diver’s Report indicated the steel sheet piles for the cell walls vary in thickness from 0.320 to 0.390 inches. No pitting was documented for these cells. The Diver’s Report also indicated less than 3 percent of the exposed surface area of the cell walls was affected by surface corrosion. The Diver’s Report indicated Cells 1 through 6 leaned towards the east (towards the water), ranging from 1.9 to 4.5 degrees, and Cell 7 leaned 1.7 to 2.3 degrees. The degree of lean of the sheet piles was obtained by using a 2-foot long smart level on the portion of wall above the waterline. However, the lean is likely less at the streambed than it is at the top of the sheet pile.

Normal installation tolerance for sheet piles is ¼ inch per foot of lean, which equates to a lean of approximately 1.2 degrees. Therefore, the maximum actual lean in Cells 1 through 6 is nearly 4 times the normal allowance for installation. Hanson suspects the sheet piles were likely driven within tolerance (or relatively close) and were pushed laterally by the trees that grew behind them at the top of the retaining walls. The actual lean of Cell 7 along the southwest side is 2.3 degrees towards the east (inward). If rocks were encountered during the driving of the sheet piles and no construction oversight was provided, it is possible this cell was driven to its current configuration.

Photo 10 – Retaining Wall Cells 1 - 3 (Cell 1 is Shown on the Right End)

- In the future, all saplings should be removed before they are allowed to grow and cause further damage to the sheet pile retaining wall.

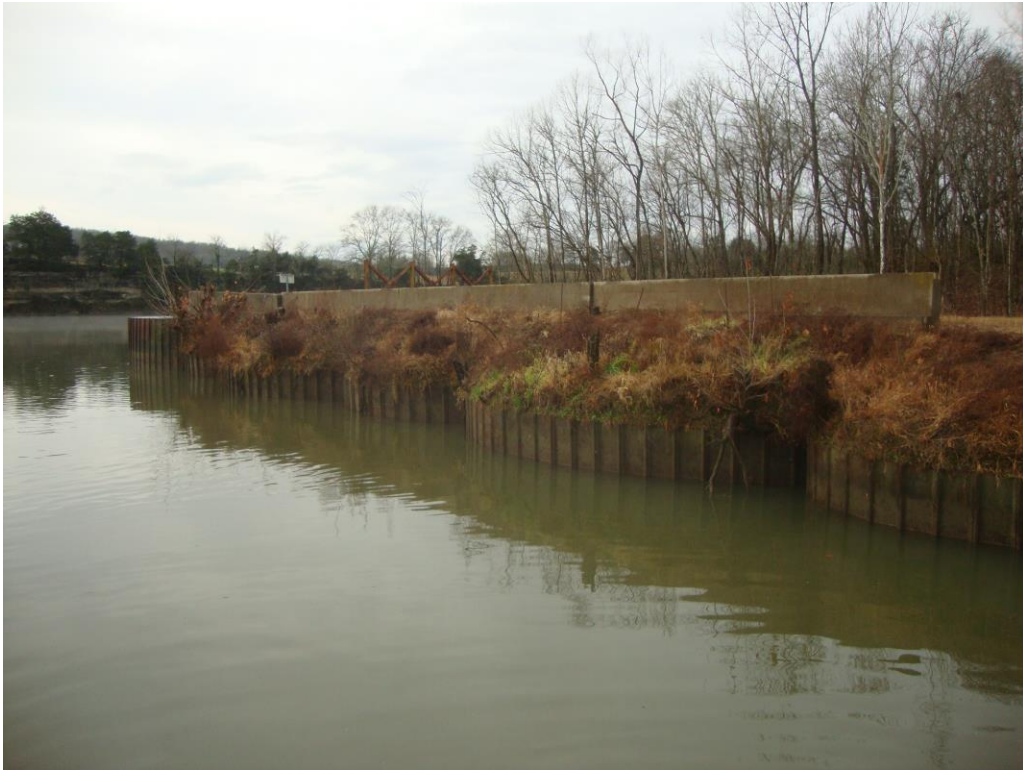
The concrete cap on top of Cell 7 had hairline cracks but appeared to be in relatively good condition. The concrete cap did not appear to have settled and no significant voids were detected by sounding the concrete with a hammer. During the site visit, it was noted that sometime in the past trees were allowed to grow behind Cells 1 through 6, with only stumps remaining.

Photo 11 – Retaining Wall Cells 2 - 7 (Cell 7 is Shown on the Left End)

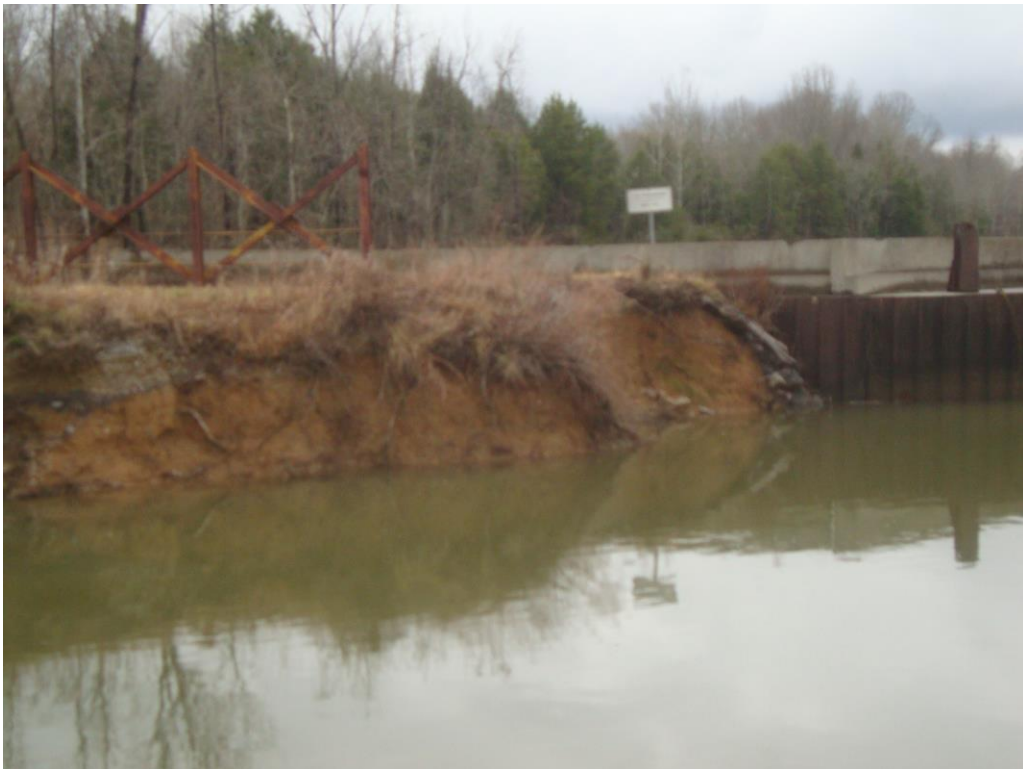
Photo 12 – Unprotected Shoreline North and Northwest of Cell 7

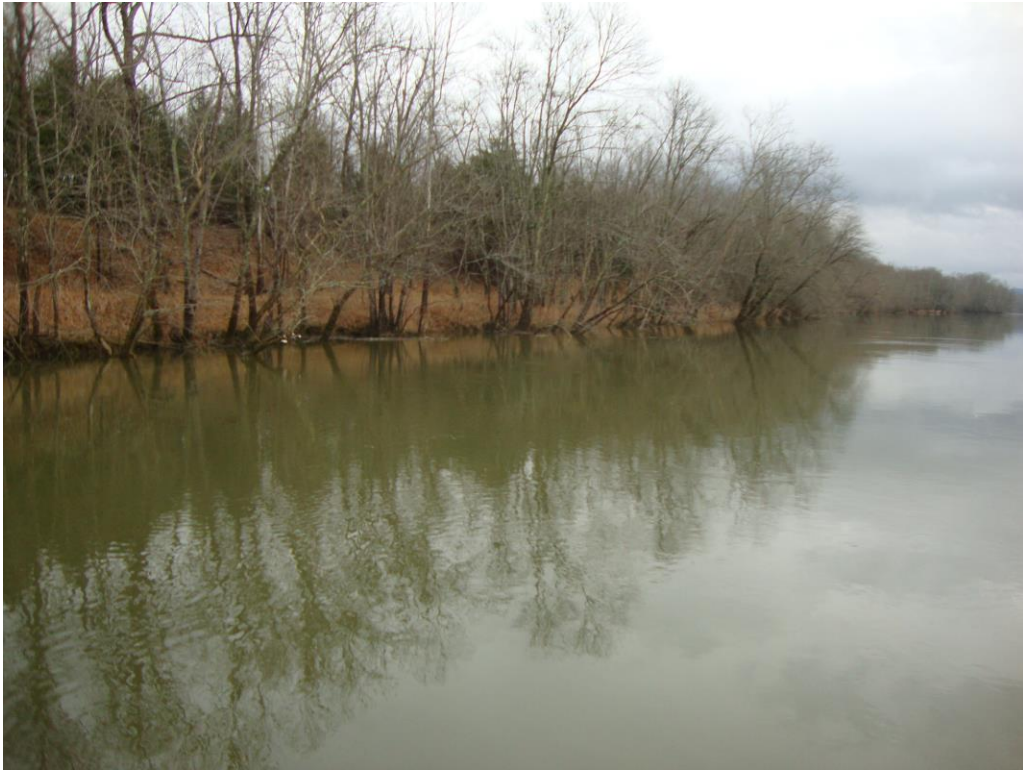
The east shoreline of the slack water area is mainly unprotected. The southeast corner of the slack water area shoreline appears to be protected by small stone riprap. Many trees of varying sizes are growing along the shoreline. Photos 13 - 16 show the east shoreline of the slack water area.

Photo 13 – East Shoreline (Looking East)

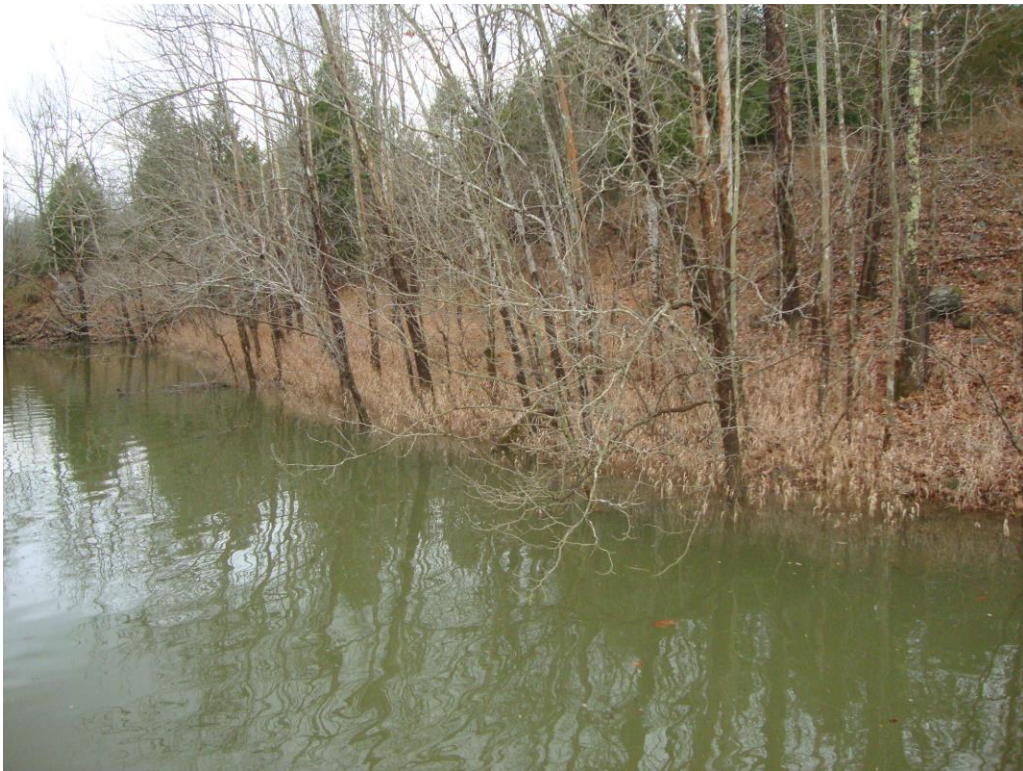
Photo 14 – East Shoreline (Looking North)

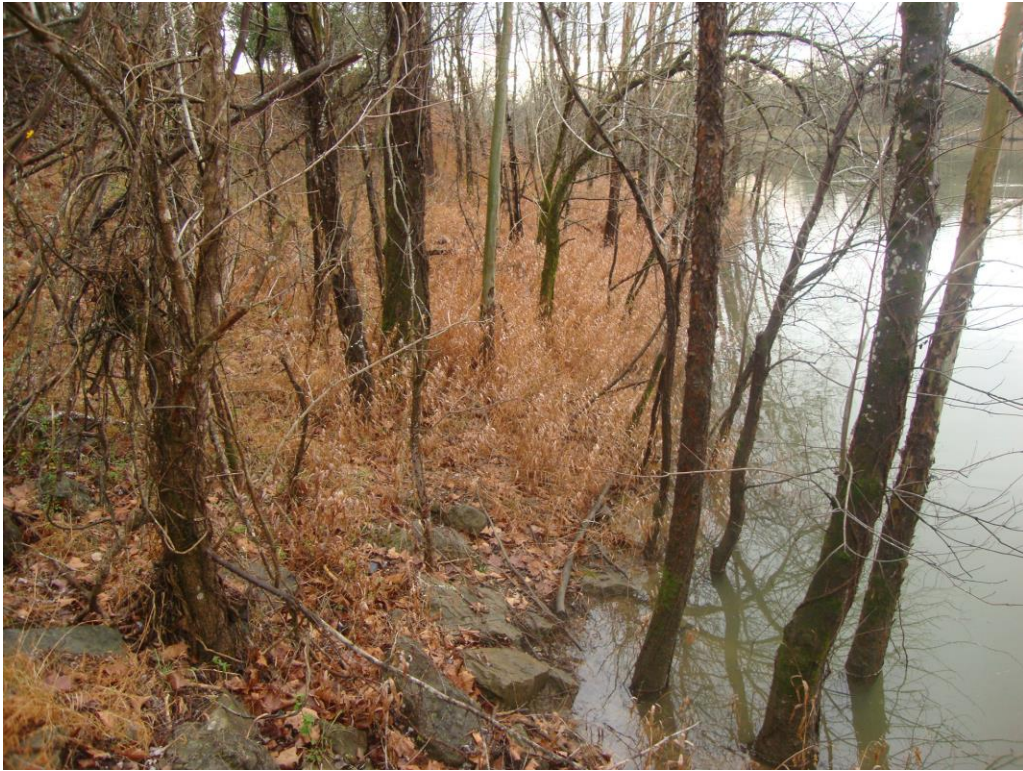
Photo 15 – East Shoreline (Looking South)

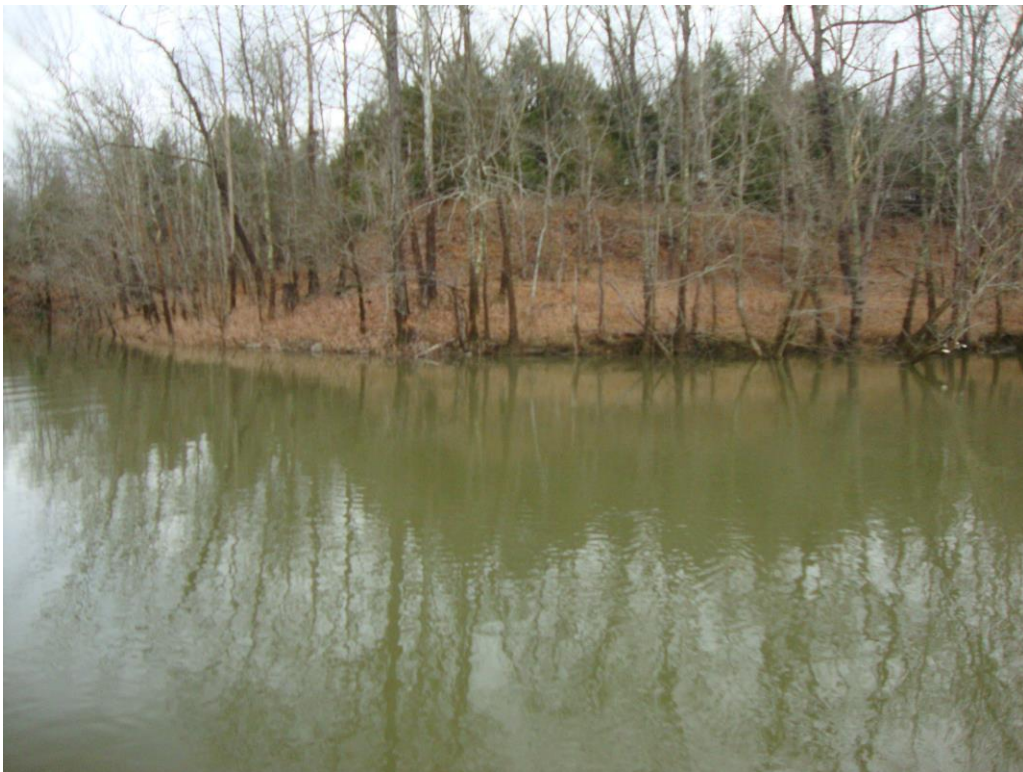
Photo 16 – Southeast Corner (Looking North)

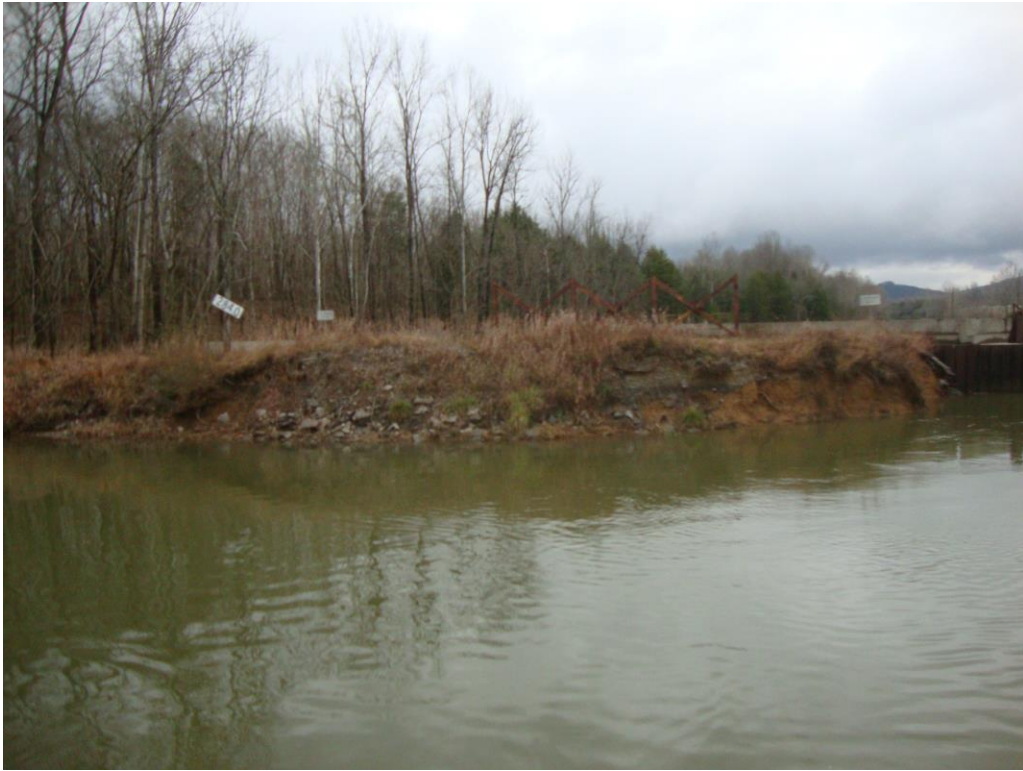
Photo 17 – Southwest Corner (Looking North)

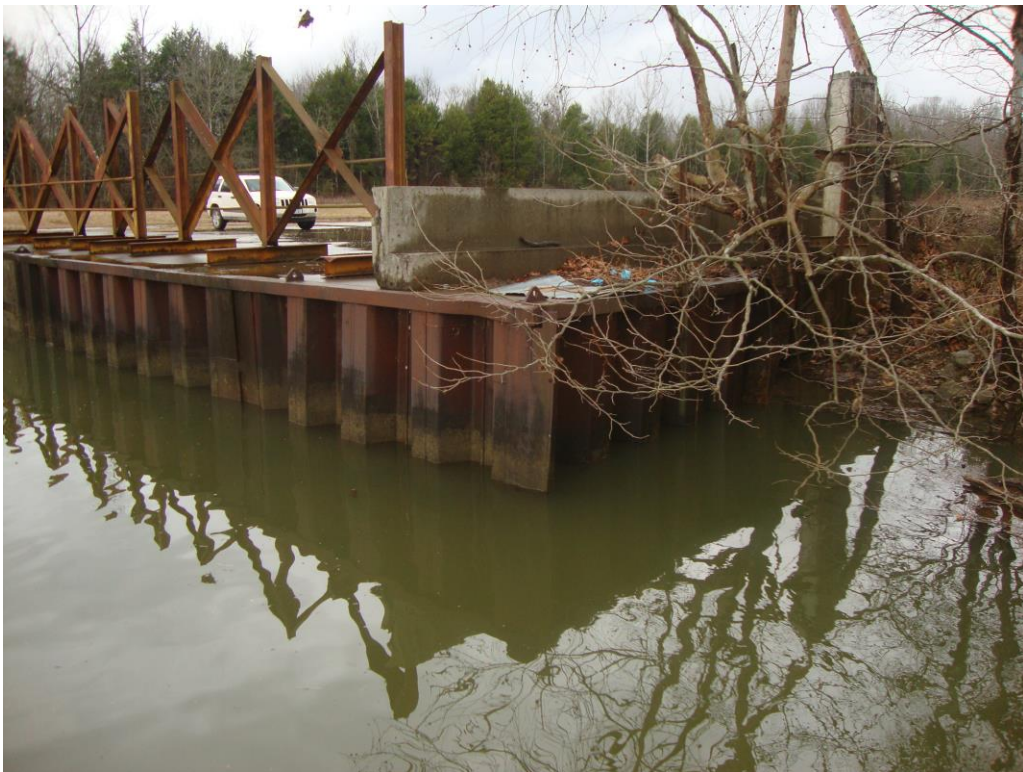
Temporary barriers are in place along the south and east edges of the dock area and behind the cells along the west face of the slack water area. Temporary barriers are also located along the shoreline downstream (west) of the slack water area. There are two types of temporary barriers at the site. One type of temporary barrier consists of precast concrete "L" shaped barriers. The other type consists of a steel truss barrier comprised of wide flange members for the vertical post, angle members for the diagonal members, and rods for the horizontal rails. The base of the steel truss members is supported by wide flange beams that bear directly on the concrete mat. These temporary barriers were not inspected and their condition was not included in this report. See Photos 18 and 19 showing the typical configuration of the steel and concrete barriers.

Photo 18 – Typical Steel and Concrete Temporary Barriers

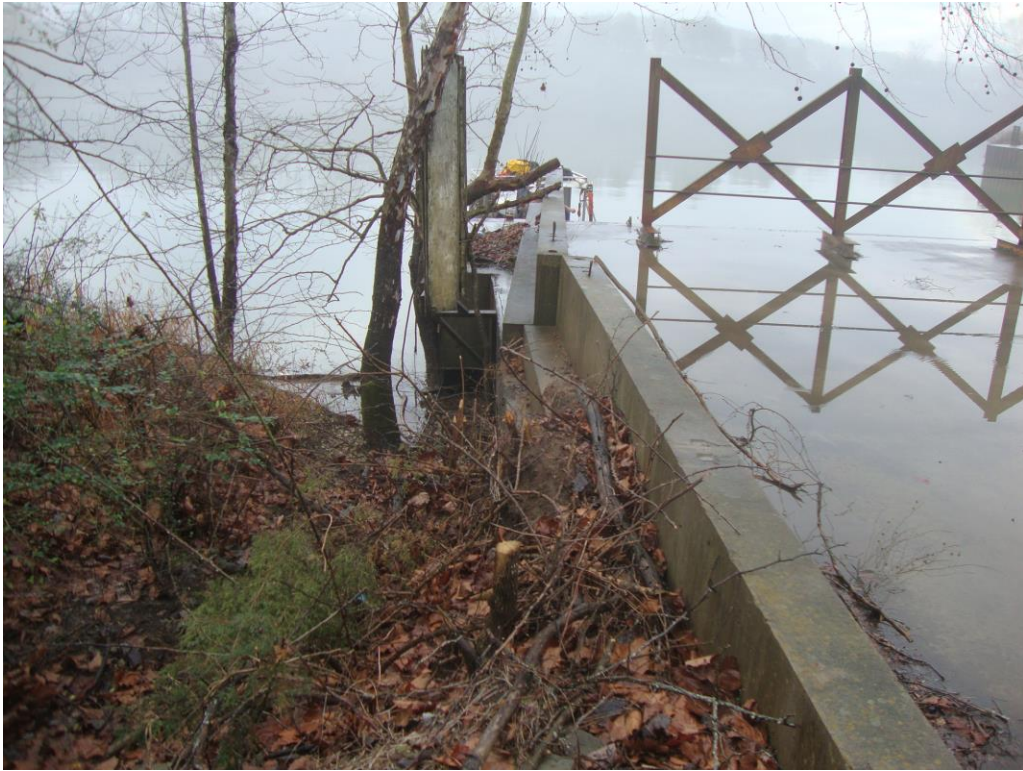
Photo 19 – Typical Steel and Concrete Temporary Barriers

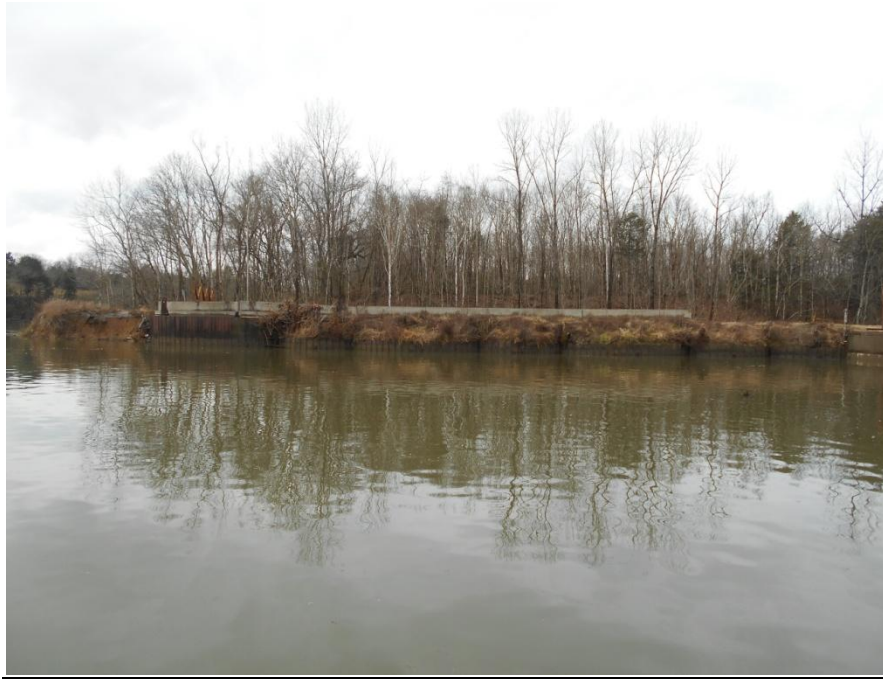
Photo 1: Cell designed portion of the dock terminal.

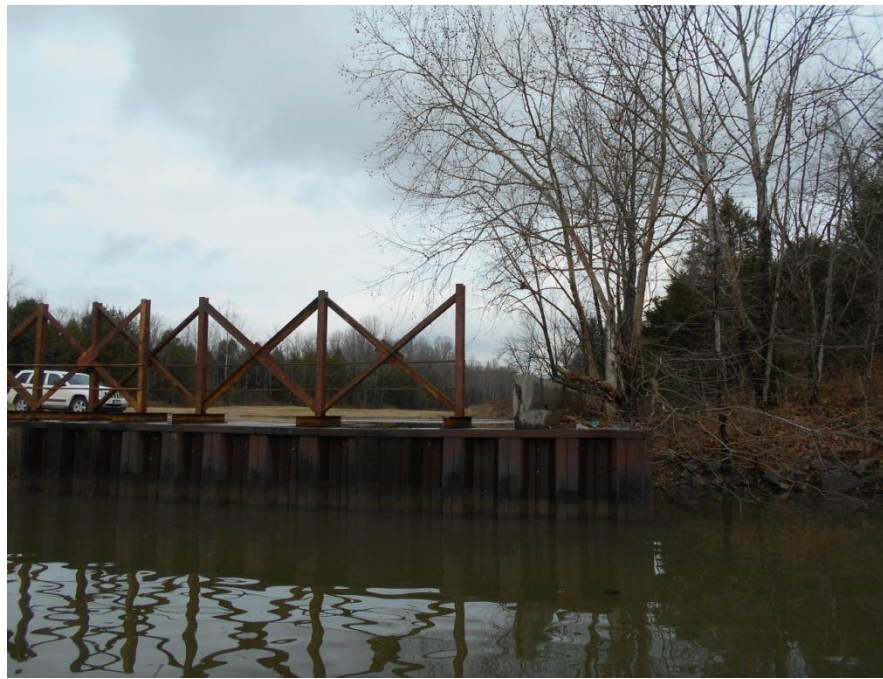
Photo 2: Z Sheet pile wall (northeast corner)

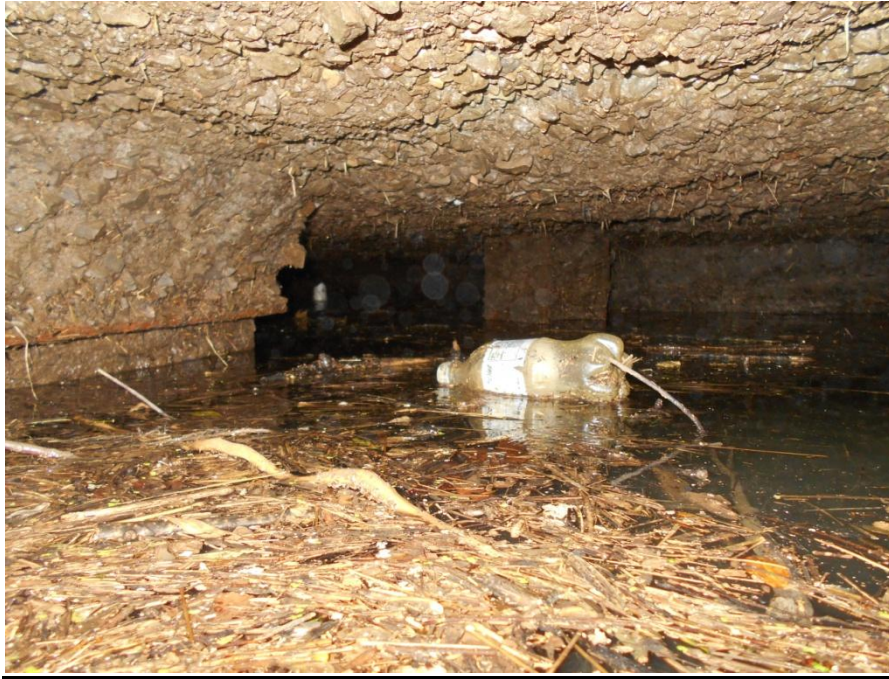
Photo 3: Void at the northeast corner

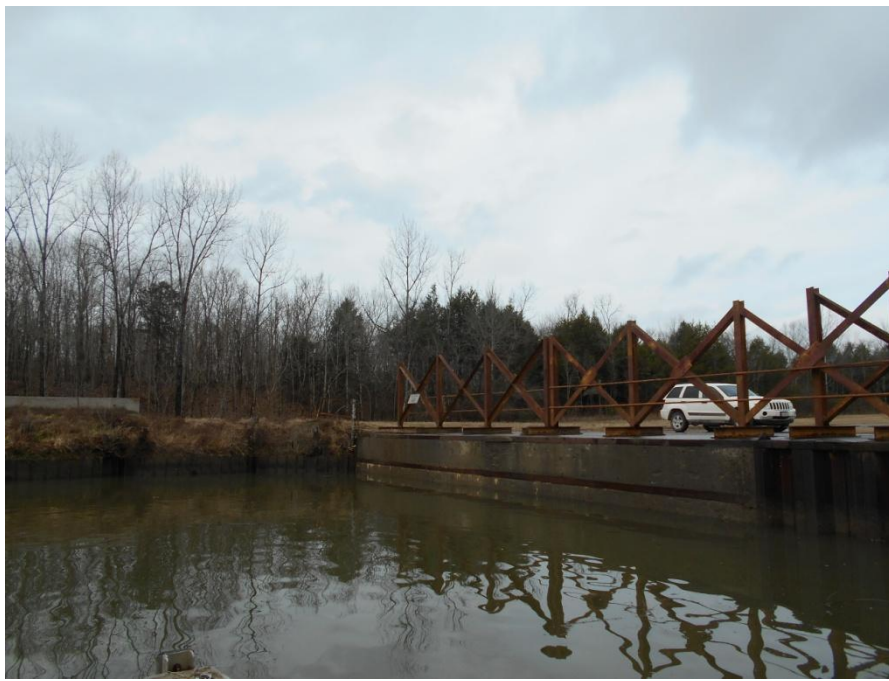
Photo 4: Concrete cap over Z- sheet pile wall

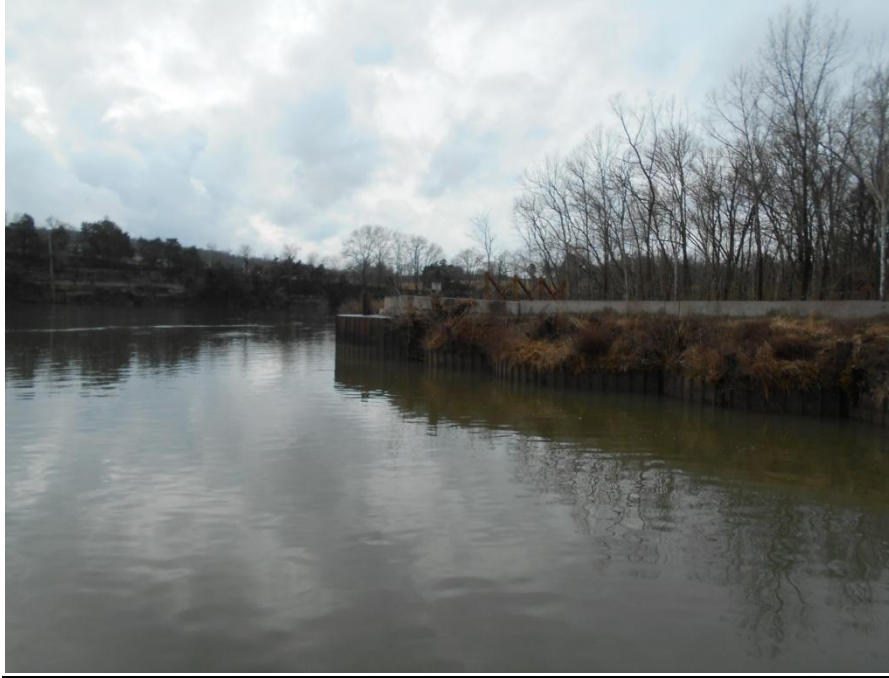
Photo 5: Looking south toward the 7th cell
