Structural Condition Assessment
River Terminal Dock Structure
Hartsville, Tennessee

PowerCom Industrial Center

Four Lake Regional Industrial
Development Authority

May 17, 2016

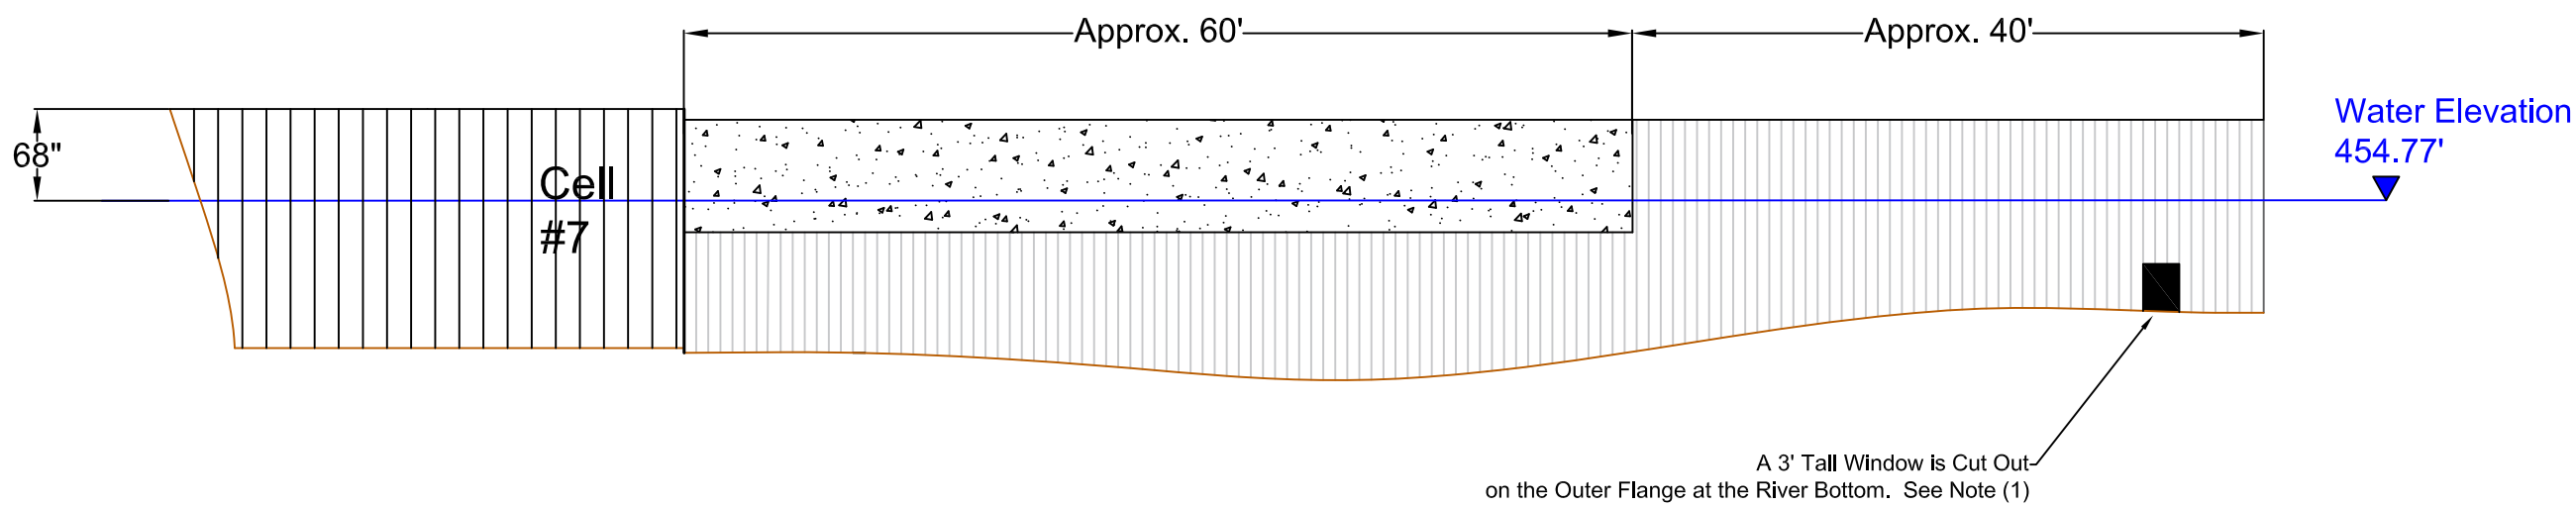
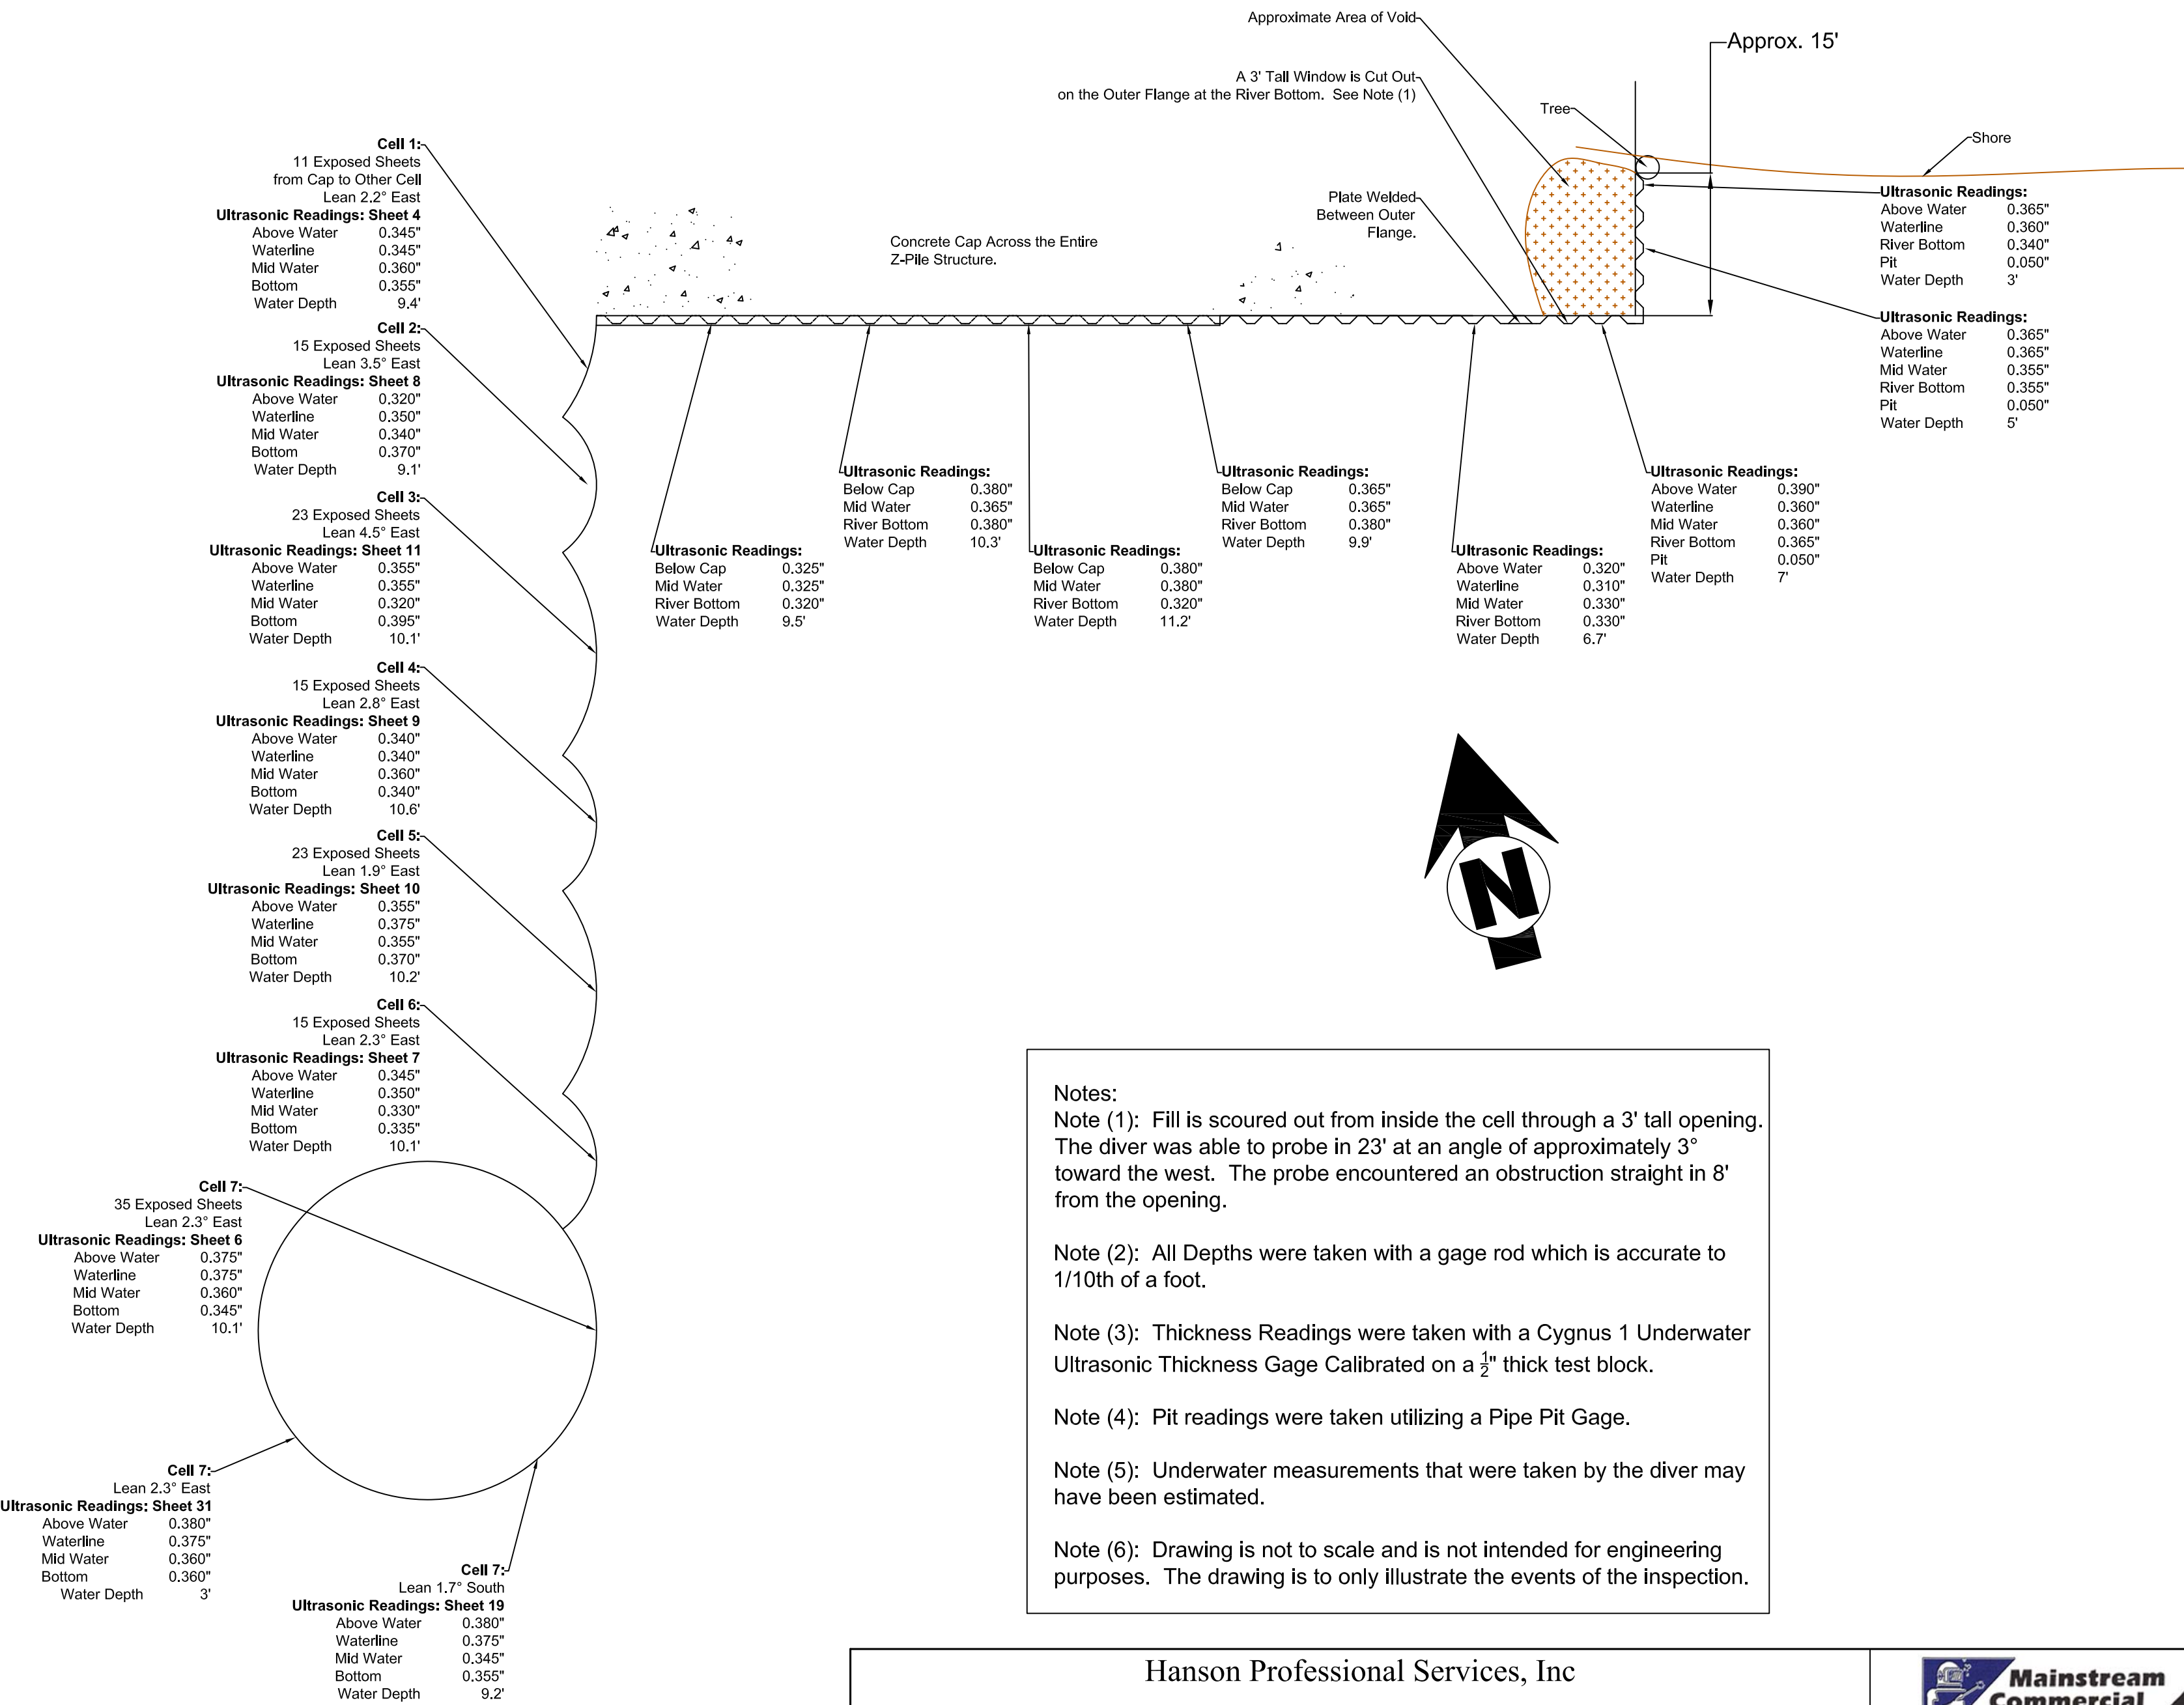
DWG
1 of 1

The interlocking “Z” shaped steel sheet piles were in relatively good condition. No splits or separations were observed in the steel sheet piles during the site visit. However, a hole approximately 3 feet high by 2 feet wide appeared to be torch cut through the steel sheet piles. This hole was located along the south face of the dock near the southeast corner. The approximate location of the hole is shown on the Plan and Profile Sheet provided in the Diver’s Report.

Note (1): Fill is scoured out from inside the cell through a 3' tall opening. The diver was able to probe in 23' at an angle of approximately 3° toward the west. The probe encountered an obstruction straight in 8' from the opening.
